ACCIDENT REPORT OF FLIGHT AF 447

(extracts from INTERIM REPORTS by the Bureau d'Enquêtes et d'Analyses
pour la sécurité de l'aviation civile - www.bea.aero)

Compiled & adapted for training purposes by Thierry HERMAS

Synopsis

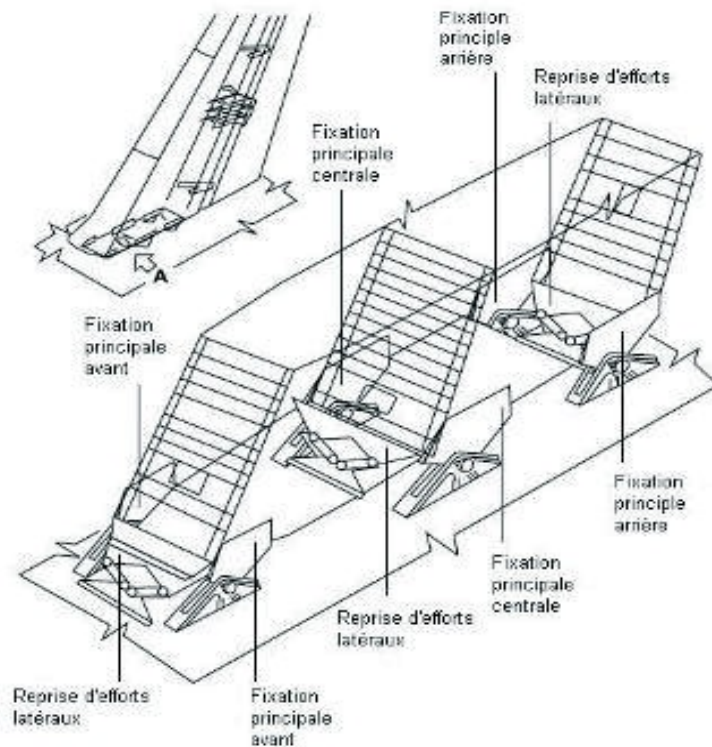
Stabiliser attachment diagram © www.bea.aero

High levels of loading would be required to cause the damage observed forward of the vertical stabiliser (compression failure of the forward attachment). These observations are not compatible with a separation of the aft part of the fuselage in flight.

The damage found at the root of the vertical stabiliser was more or less symmetrical, as were the deformations due to the high rate of compression observed on the various parts of the aircraft. This left-right symmetry means that the aircraft had low bank and little sideslip on impact.

The deformations of the fuselage frames at the root of the vertical stabiliser were not consistent with an aircraft nose-down attitude at the moment of impact.

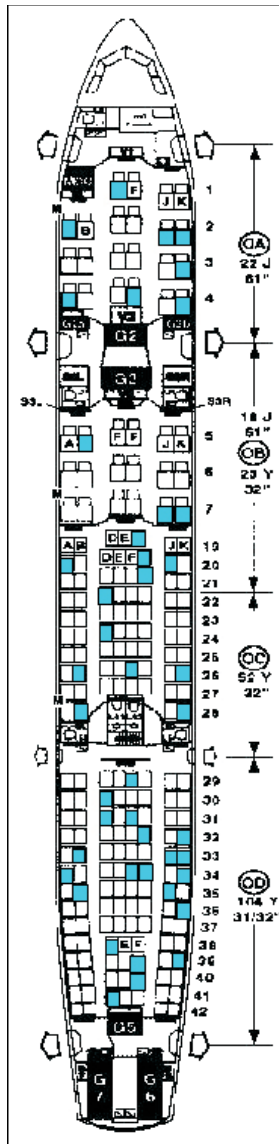
In blue, the seats occupied by the victims whose bodies were recovered based on the seats attributed during check-in
